Remedial Investigation Work Plan

Sendero Verde Redevelopment Project –
Parcel B
Block 1617, Lot 20
New York, New York

November 28, 2018

**Roux Environmental Engineering
and Geology, D.P.C.**
209 Shafter Street
Islandia, New York 11749

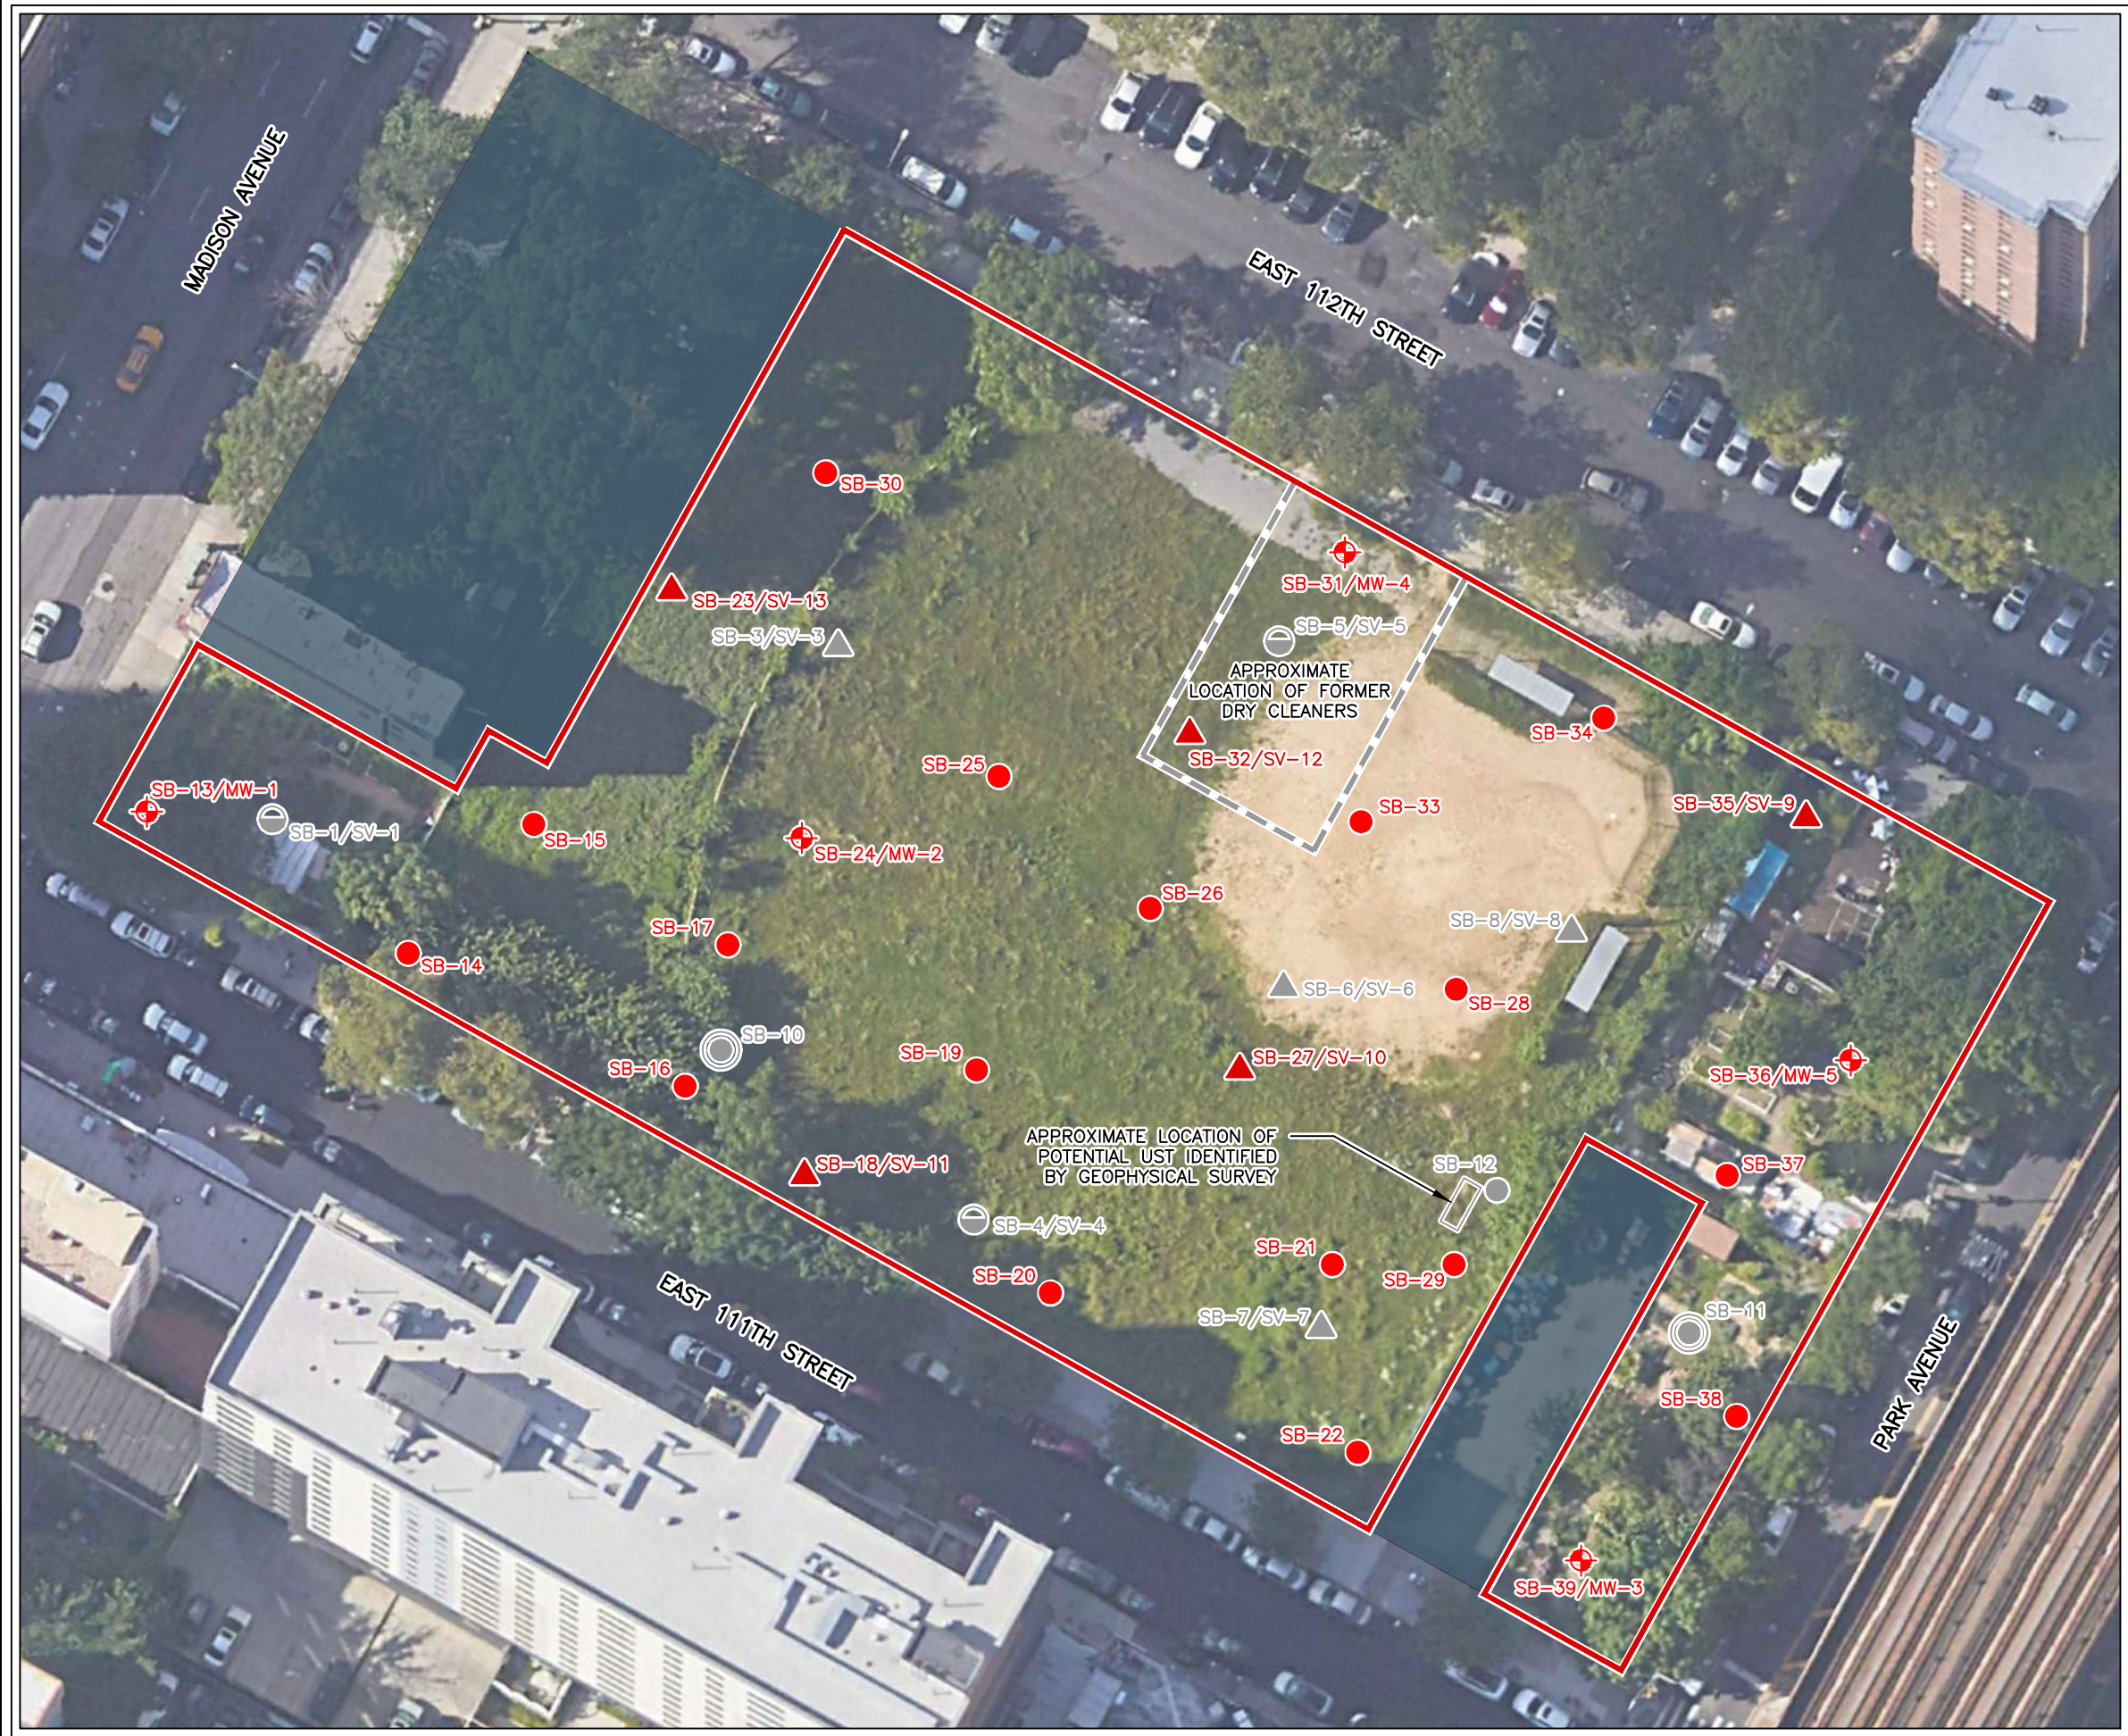
To characterize the soil conditions for the AOCs at the Site and fill existing data gaps in vertical delineation of contamination, twenty-four (24) soil borings will be installed at the locations shown in Figure 3. Boreholes will be pre-cleared to five ft bls using non-intrusive methods, such as hand tools and/or vacuum excavation, prior to advancement of soil borings to verify the absence of utilities and/or other subsurface features (i.e. obstructions). Should a utility or other feature be observed during pre-clearance activities, the sampling location will be relocated to no more than ten feet away from the original proposed sample location. If a boring is proposed to be moved more than ten feet from the location shown on Figure 3, the NYSDEC project manager will be consulted prior to installing the boring at the new location. Soil samples will be collected by hand or by utilizing the GeoProbe® Direct-Push Drill Rig. Soil samples will be collected continuously from land surface to the water table or the interval below the planned excavation depth. During installation of the soil borings, the lithology will be recorded, and soil will be inspected for evidence (visual or olfactory) of contamination and field screened continuously for VOCs using a PID with a 10.6 eV lamp.

To characterize Site groundwater flow and quality conditions and to evaluate for potential off-Site migration, five (5) permanent groundwater monitoring wells (MW-1 through MW-5) will be installed at selected soil boring locations. The proposed groundwater monitoring well locations are shown on Figure 3.

Two focused borings (SB-31 and SB-32) will be completed in the north and southwest sides of the area where the presumed former dry cleaner was historically located. Up to two (2) soil samples will be collected from each boring to be submitted for laboratory analysis. One soil sample will be collected from the first two-foot interval of soil representing surface soils at the Site. A second sample will be collected from the two-foot interval exhibiting the greatest evidence of impact (elevated PID detections, odors, or staining). If no

If the presence of the UST is confirmed, soil boring SB-29 will be completed downgradient of the UST location. Up to two (2) soil samples will be collected from the boring to be submitted for laboratory analysis. One (1) soil sample will be collected from the first two-foot interval of soil representing surface soils at the Site. A second sample will be collected from the two-foot interval exhibiting the greatest evidence of impact (elevated PID detections, odors, or staining). If no evidence of impacts is observed during soil boring advancement, the soil sample will be collected from the two-foot interval below the proposed foundation excavation depth (11-13 ft bls). In the event that impacts are observed, additional soil samples will be collected from two-foot intervals located beneath the visually impacted interval to vertically delineate the extent of the impacts.

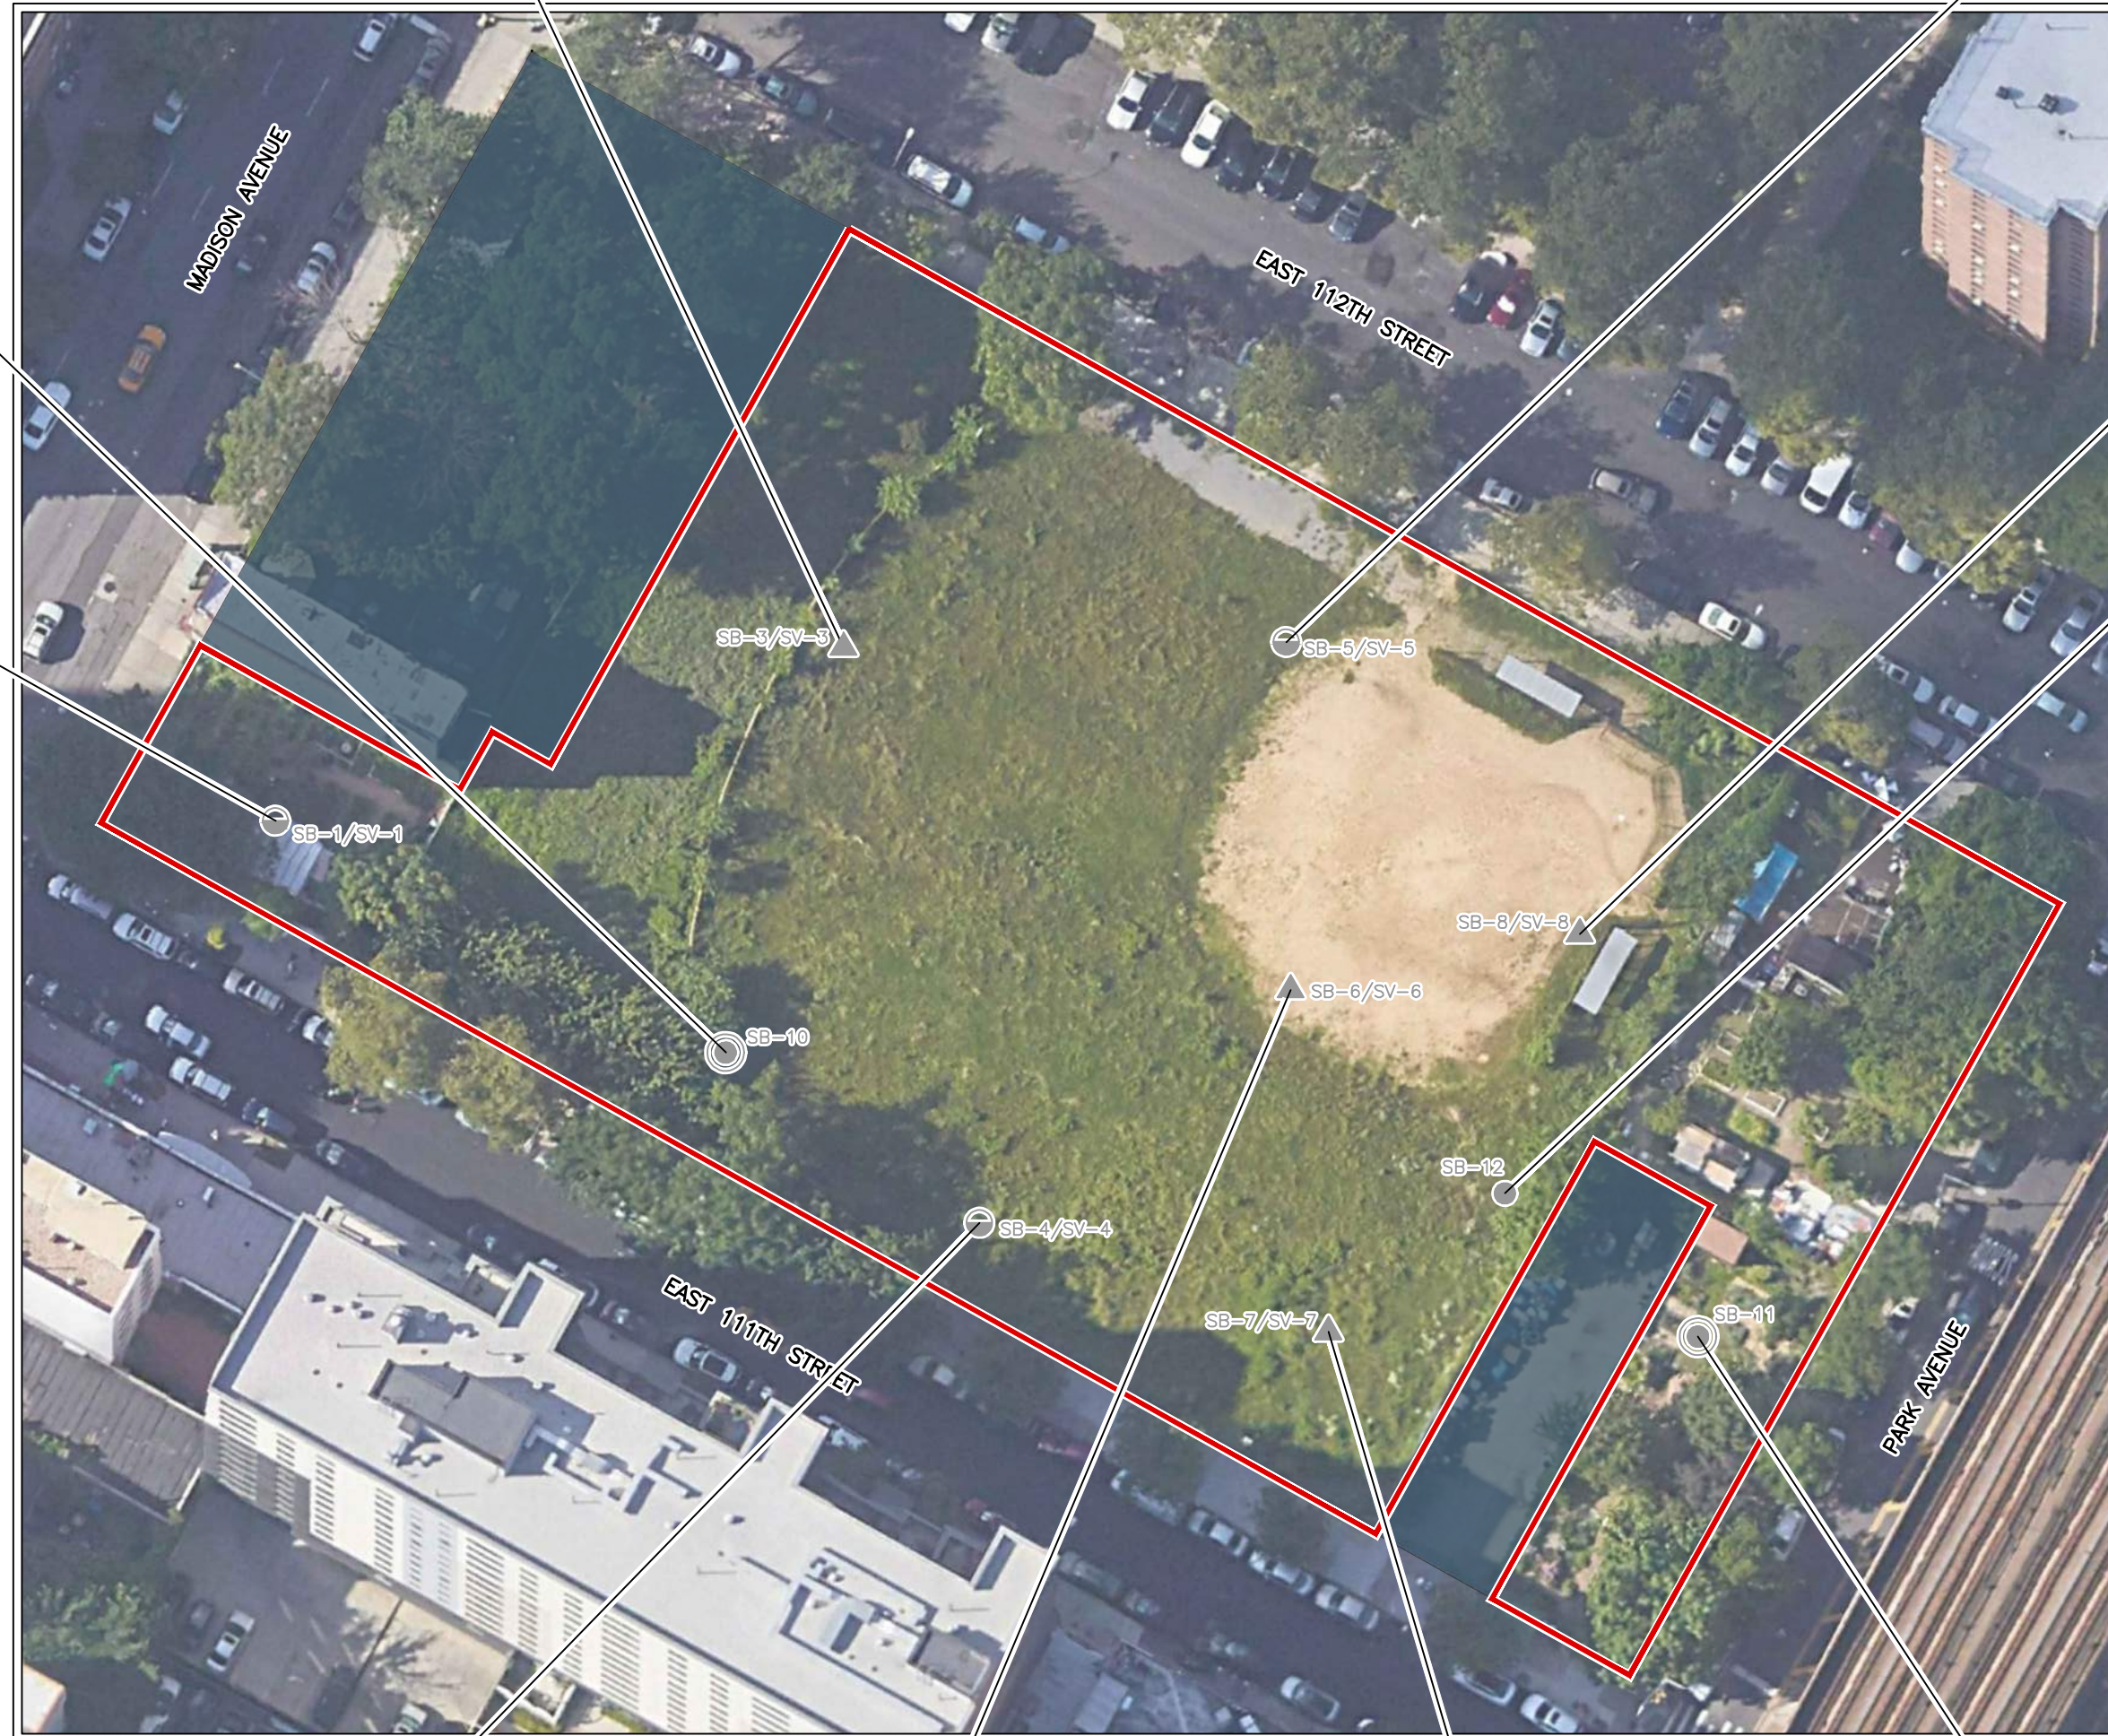
SB-1	5/1/2018	5/2/2018
Depth (ft bls)	0 - 2	12 - 14
SVOC		
Benzo(A)Anthracene	3200	1800
Benzo(A)Pyrene	2800	2000
Benzo(B)Fluoranthene	4400	3000
Benzo(K)Fluoranthene	1300	1100
Chrysene	3400	2100
Dibenz(A,H)Anthracene	500	370
Indeno(1,2,3-C,D)Pyrene	2000	1800
Metals		
Barium	403	418
Copper	5060	NE
Lead	458	820
Mercury	0.259	0.302
Zinc	436	617
PCB		
Polychlorinated Biphenyl (PCBs)	355 J	132 J
Pesticides		
Dieldrin	33.3	146
P,P'-DDD	ND	12.5 PI
P,P'-DDE	29.6	37.6
P,P'-DDT	235	307

SB-8	4/30/2018	5/3/2018
Depth (ft bls)	0 - 2	18 - 20
Pesticides		
Dieldrin	6.16	ND
P,P'-DDE	12	ND
P,P'-DDT	47.2	ND

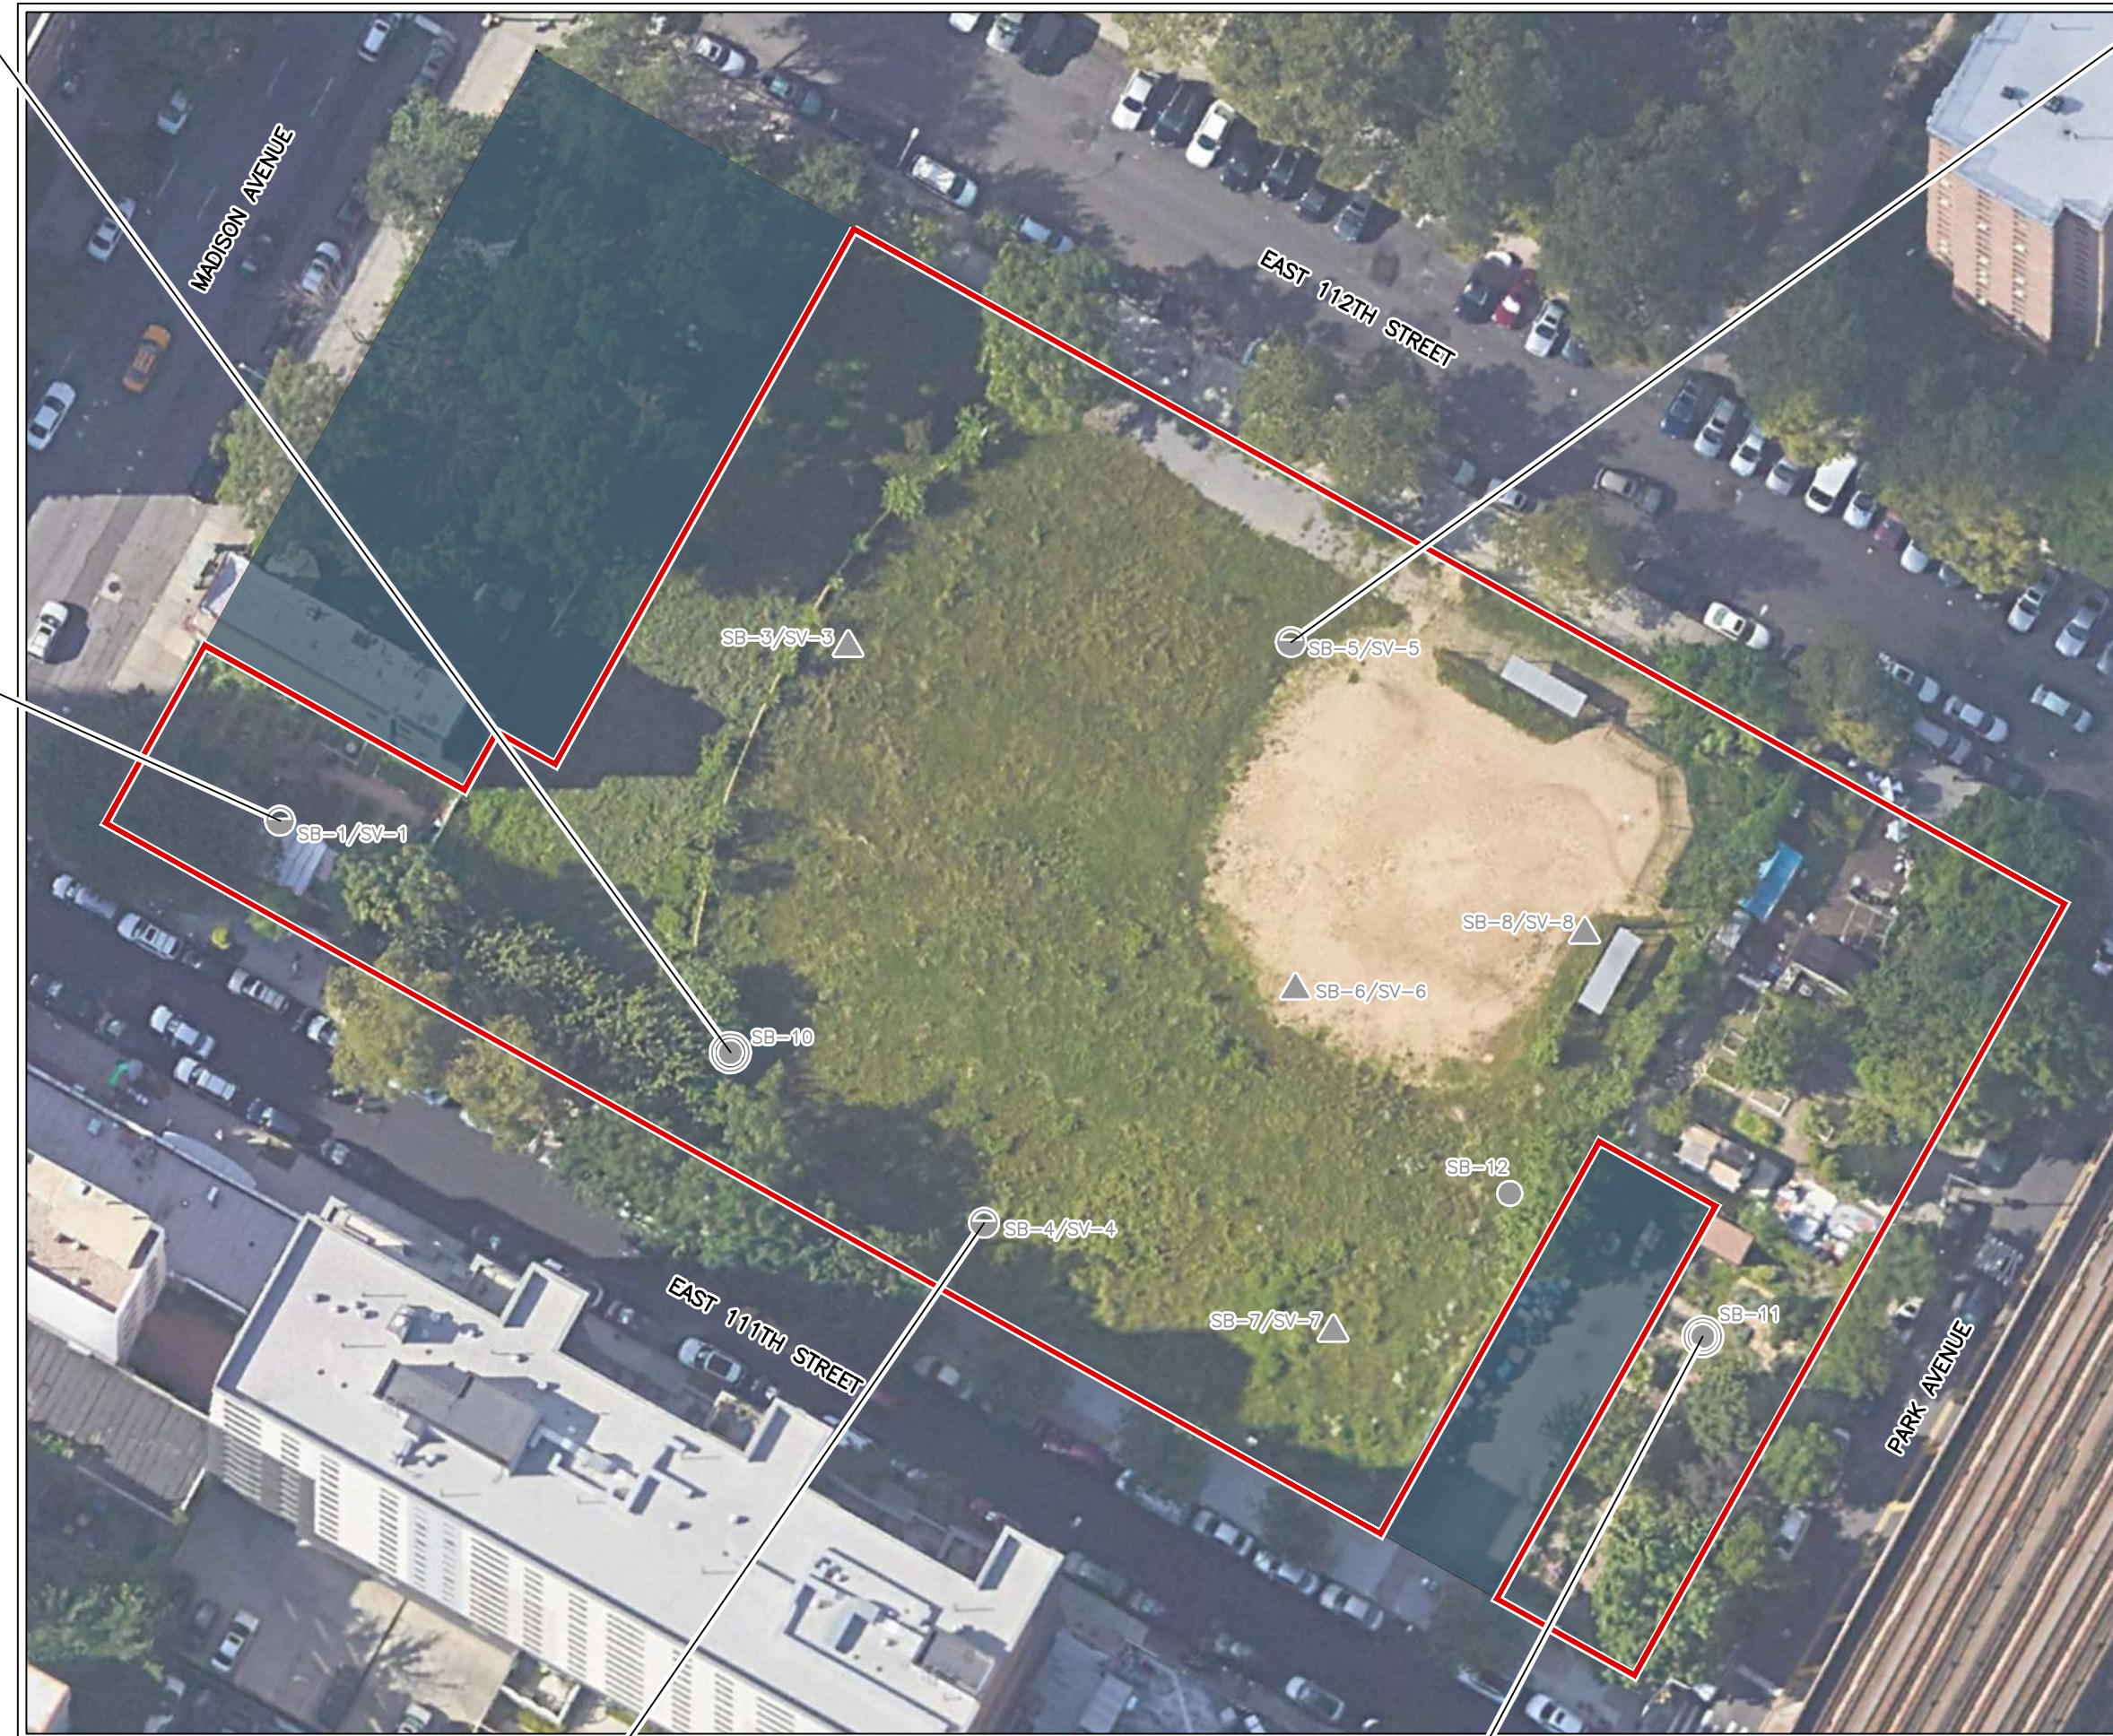
SB-4	5/2/2018	5/2/2018	5/2/2018
Sample Note			Filtered
Sample Fraction	Total	Dissolved	Total
VOC			
Chloroform	30	NA	NA
SVOC			
Bis(2-Ethylhexyl) Phthalate	ND	NA	9.4
METALS			
Barium	3150	NE	NA
Chromium, Total	68.41	NE	NA
Iron	22200	ND	NA
Lead	285.7	NE	NA
Manganese	843.5	NE	NA
Sodium	NE	21000	NA
PEST			
Chlordane	0.074 J	NA	ND
Dieldrin	0.021 J	NA	0.022 J

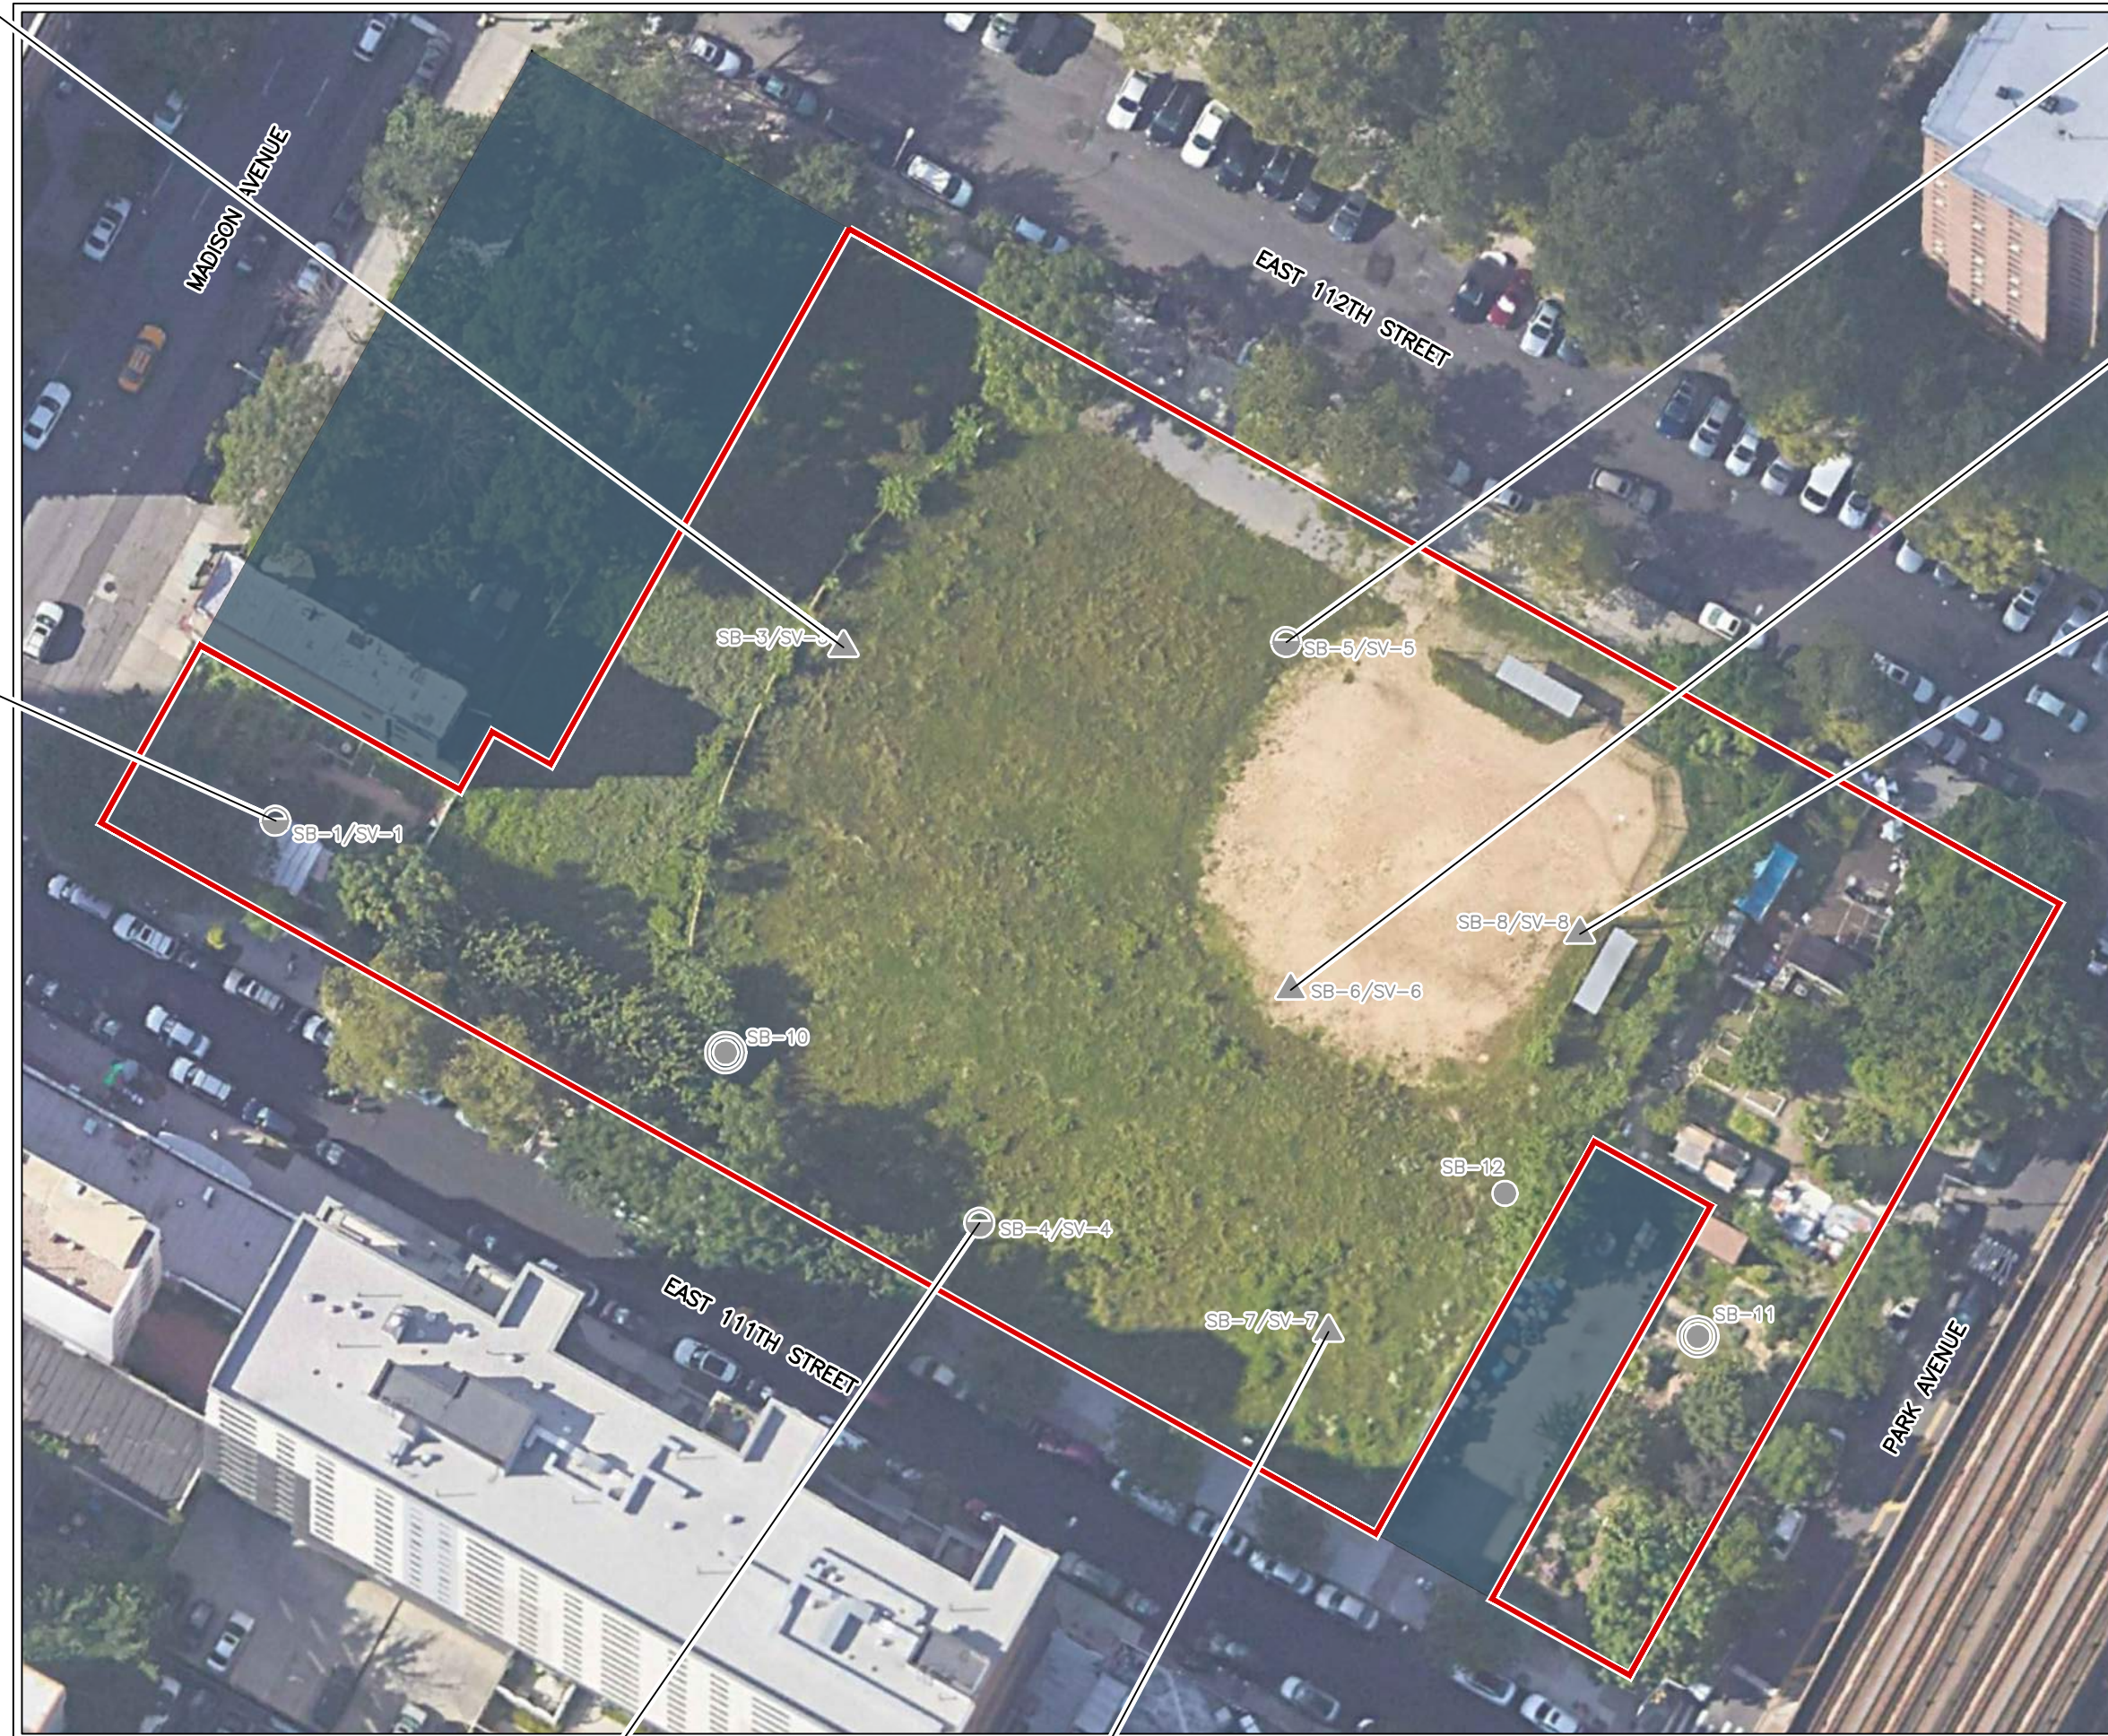
SV-1	5/4/2018
1,2,4-Trimethylbenzene	15
2-Hexanone	161
Acetone	120
m,p-Xylene	14.9
Methyl Ethyl Ketone (2-Butanone)	817
O-Xylene (1,2-Dimethylbenzene)	7.3
Toluene	4.75

SV-5	5/4/2018
2-Hexanone	194
Acetone	551
Ethanol	111
Methyl Ethyl Ketone (2-Butanone)	1710
N-Heptane	13.9
N-Hexane	20.7
